CHAPTER 2: GEOLOGIC HAZARDS

TECHNICAL BACKGROUND REPORT TO THE SAFETY ELEMENT UPDATE CITY of COACHELLA, CALIFORNIA

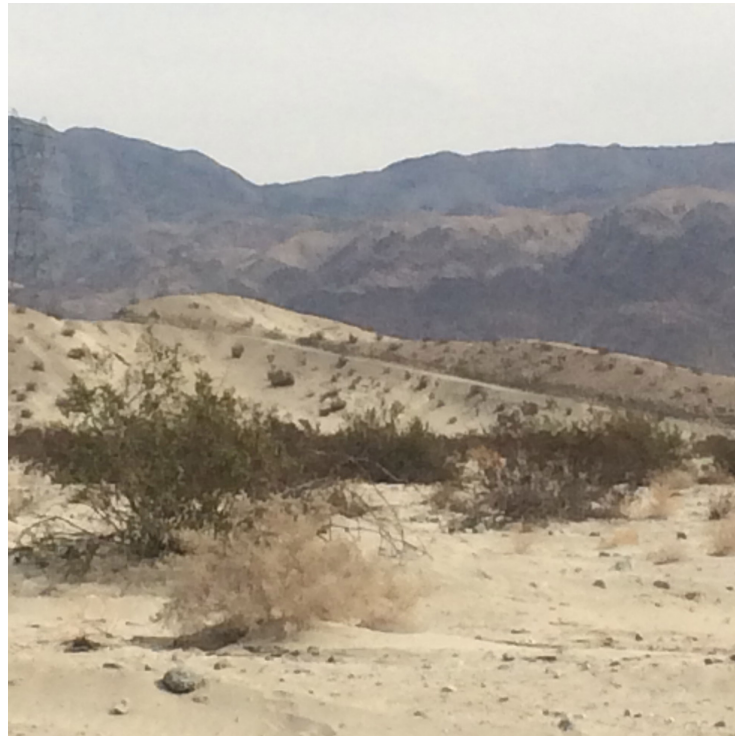
Figure 2-1: Geologic Units in the Coachella Area. The sands in the foreground are alluvial deposits reworked by the wind; the hills in the middle are comprised of the Upper Ocotillo Conglomerate, whereas the mountains in the far distance consist of crystalline rocks.

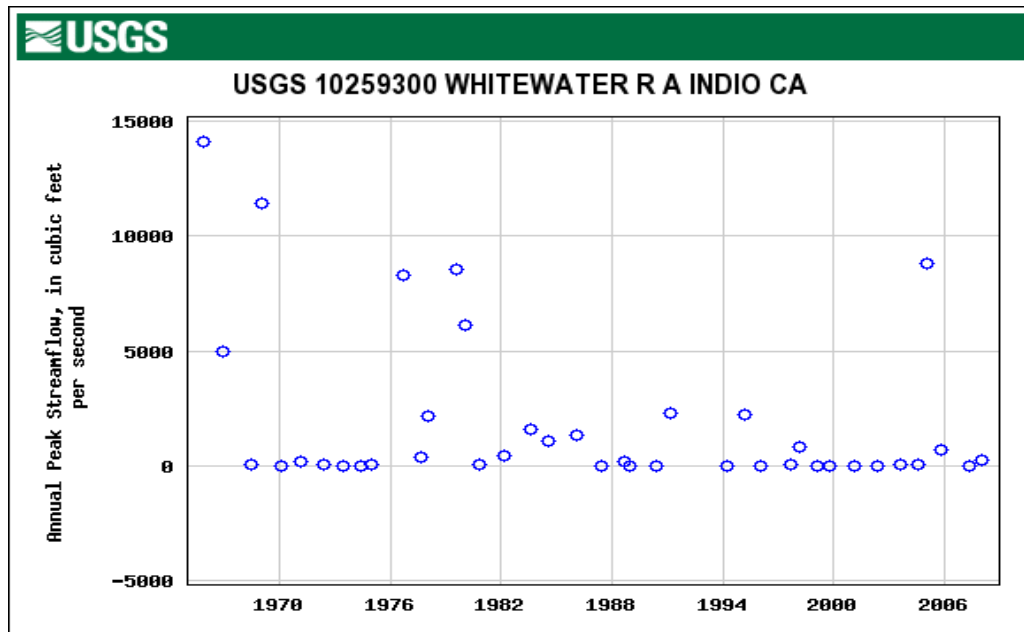
Figure 3-1: Peak Annual Streamflow Values for Gage Station USGS 10259300 Located on the Whitewater River in Indio, Near Coachella

Data for 1966 through 2008. Drainage basin size: 1,073 square miles.

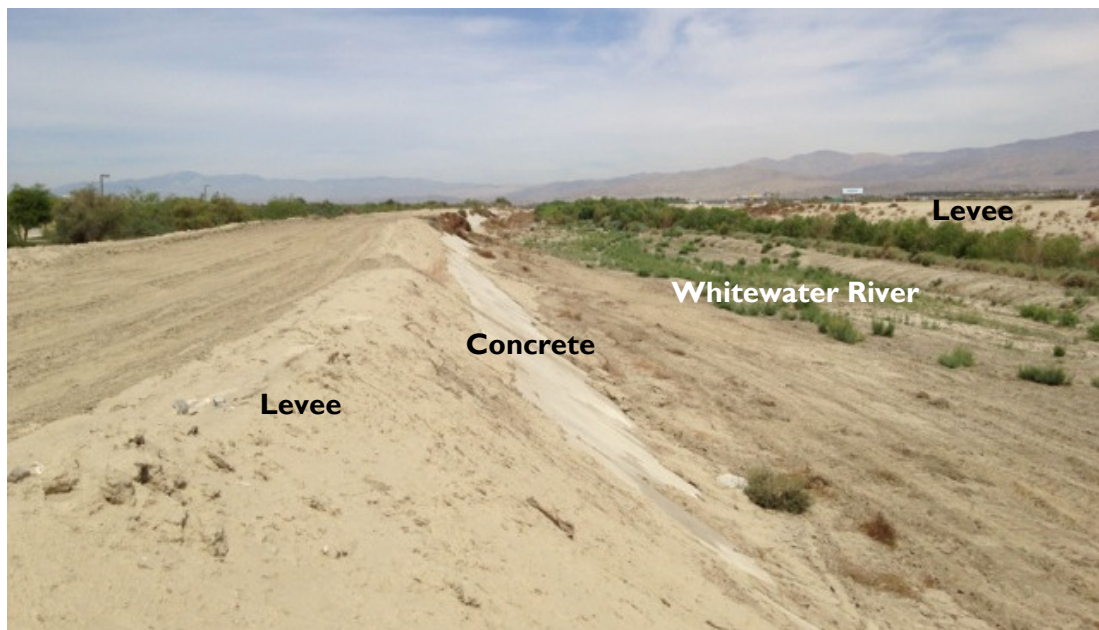
The Whitewater River's course through Coachella is confined to this broad, soft-bottom channel. The western bank of the channel is reinforced with concrete north of Avenue 54.

This view, looking north from Avenue 50, shows the sand levees along the channel and concrete facing on the western bank.

Levees constructed of large sandpiles with no reinforcement occur along both sides of the channel (see Plate 3-1). The levees are easily eroded and require periodic maintenance. According to the most recent (August 2008b) FIRMs, and the CVWD, the levees along the Whitewater River that protect Coachella from the 100-year flood are currently not accredited. Detailed hydraulic analyses, based on the new FEMA procedures, were performed by the CVWD for the reach extending from the Monroe Street bridge (in the city of Indio) to the Salton Sea. The result of these analyses indicated areas adjacent to channel, from just north of Airport Boulevard (Avenue 56) to the south, are susceptible to inundation from a levee breach

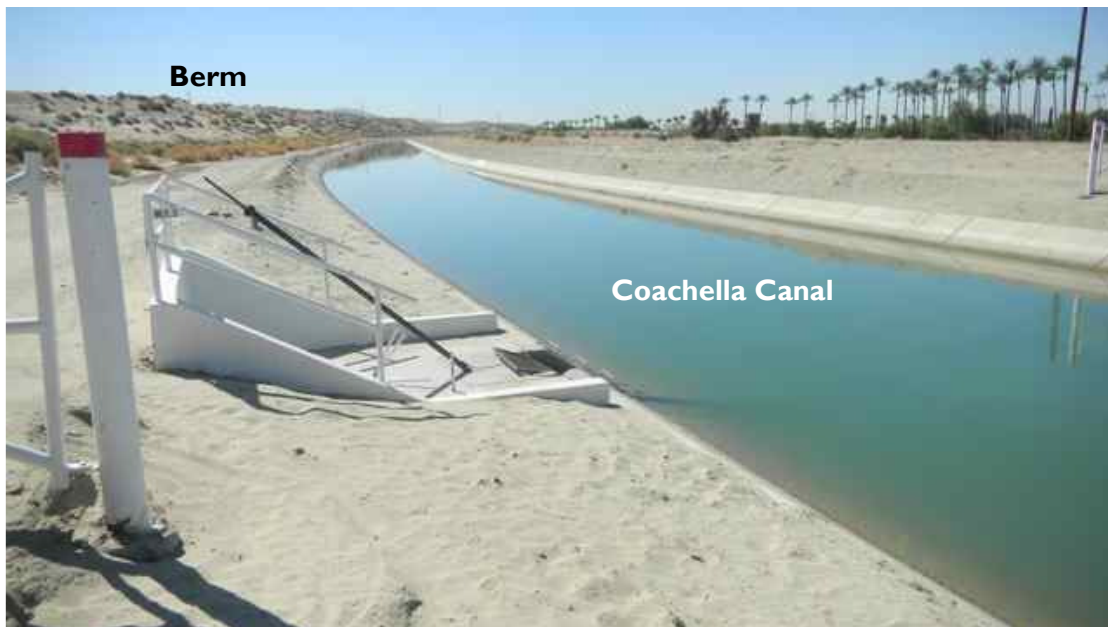
Figure 3-3: Coachella Canal and Eastside Dike.

The Eastside Dike, the earthen berm shown in the upper left corner of the photo, protects the Coachella Canal from stormwater flowing out of the nearby hills and mountains.

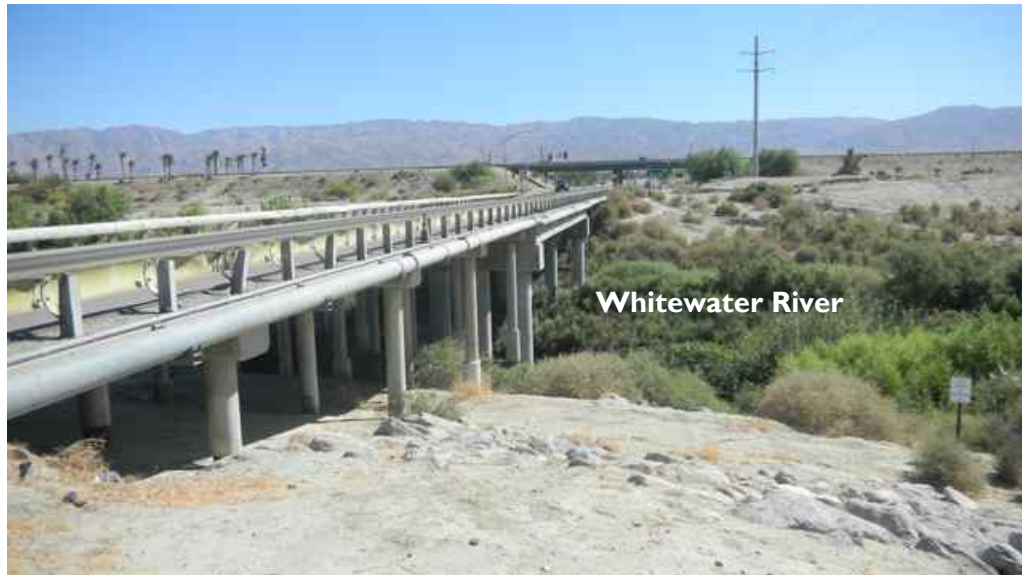
**Figure 3-4: Bridge Crossing the Coachella Valley Stormwater Channel
(Whitewater River) at Dillon Road**

Dillon Road, Avenue 50, Avenue 52, and Airport Boulevard (Avenue 56) are Coachella's only crossings of the Coachella Valley Stormwater Channel. Except for Avenue 50, these crossings consist of bridges over the channel. The roadway for Avenue 50 dips into the channel and is impassable when the channel is flooded. Highway 111 (Grapefruit Boulevard) and the Southern Pacific Railroad tracks cross the channel just south of Coachella. In December 1966, one of the most damaging storms on record hit the valley. Although water remained within the channel banks, the channel bed from Airport Road south to Avenue 60 was scoured so deeply it caused damage to the Airport Road bridge, threatened the stability of Highway 111, and exposed about three feet of the pile footing under the railroad bridge piers (Coachella Valley County Water District, 1967). Again, in January-February of 1969, a series of strong storms damaged roads, storm channel crossings and railroad bridges. The rail bridge and Highway 111 bridge south of Thermal were washed out, as was the Airport Road bridge just east of Thermal. In fact, between Palm Springs and the Salton Sea, the only usable crossings remaining were the Highway 86 (Indio Boulevard) bridge and the rail crossing west of Indio. It is thus very important that these crossings continue to be inspected by the City's Public Works Department, during and after flooding, for obstructions and potential scour damage.

Nationwide, several catastrophic collapses of highway and railroad bridges due to scouring and a subsequent loss of support of foundations have occurred. This has led to a nationwide inventory and evaluation of bridges (Richardson and others, 1993). Scour at highway bridges involves sediment-transport and erosion processes that cause streambed material to be removed from the bridge vicinity. Scour is generally separated into components of pier scour, abutment scour, and contraction scour. Pier scour occurs when flow impinges against the upstream side of the pier, forcing the flow in a downward direction and causing scour of the streambed adjacent to the pier. Abutment scour happens when flow impinges against the abutment, causing the flow to change direction and mix with adjacent main-channel flow, resulting in scouring forces near the abutment toe. Contraction scour occurs when flood flow is forced back through a narrower opening at the bridge, where an increase in velocity can produce scour. Total scour for a particular site is the combined effects of each component. While different materials scour at different rates, the ultimate scour attained for different materials is similar and depends mainly on the duration of peak streamflow acting on the material (Lagasse and others, 1991). Scour can occur within the main channel, on the floodplain, or both. California's seismic retrofit program of bridges includes underpinning of foundations that is expected to help reduce the vulnerability to undermining of the foundations by scour..

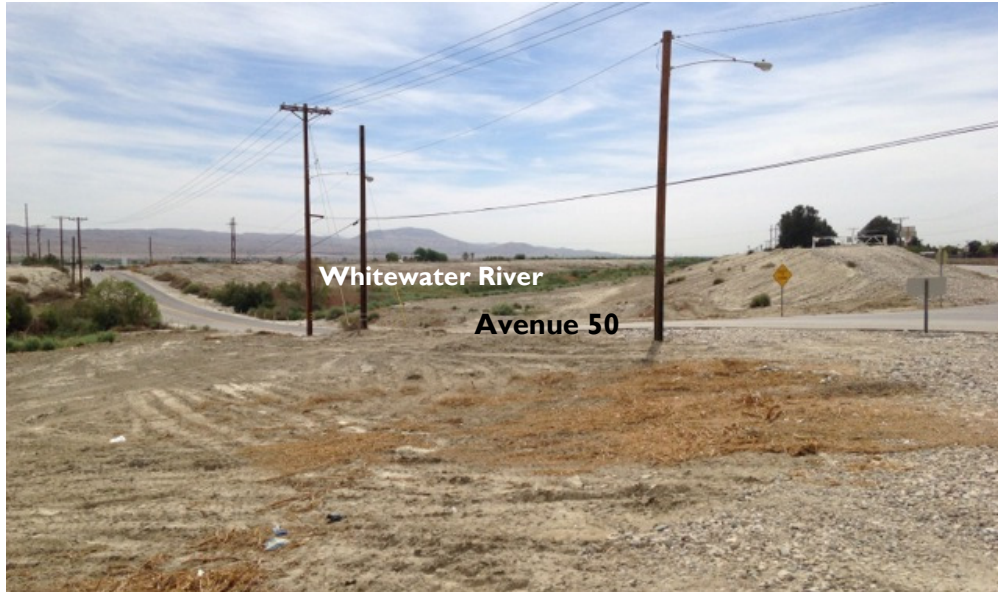
Figure 3-5: Proposed Location of New Bridge.

The city of Coachella is currently planning a bridge for the Avenue 50 dry-weather crossing.

The city's current Capital Improvement Program includes a new bridge which will replace the dry weather crossing at Avenue 50. This will allow another safe crossing of the channel during storms.

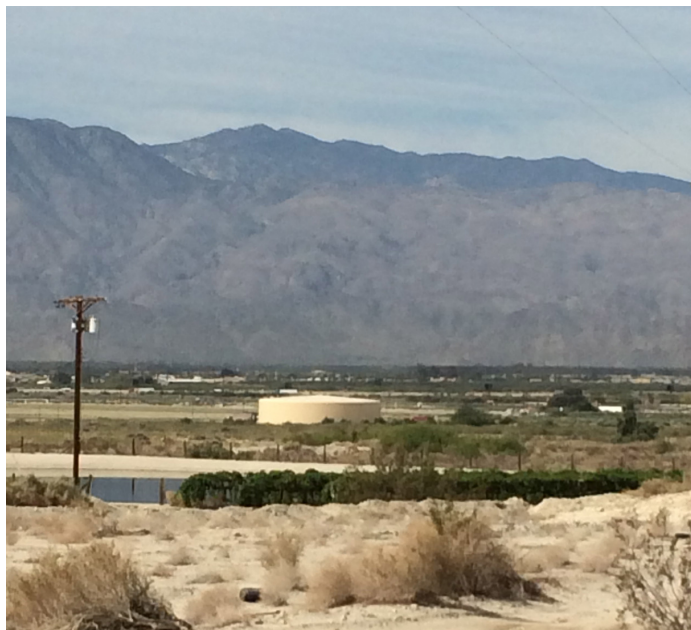
Figure 3-7: View of One of the Above-ground Water Tanks in the Coachella General Plan Area

The City of Coachella has three above-ground water reservoirs in the General Plan area. The newest tank, located at Well 18, is the only one constructed to current seismic standards. All tanks have isolation valves. The only above-ground reservoir in the Coachella General Plan area owned by the Coachella Valley Water District is located in their Coachella yard. It is an older tank that has not been retrofitted. The District is currently evaluating whether to upgrade or demolish the facility.

Reservoir	Type	Year Built	Capacity (millions of gallons)	Seismic Upgrades	Containment/ Diversion Structures
Dillon	Steel	1971	1.5	No	No
Mecca	Steel	1987	3.0	No	No
Well 18	Steel	2007	5.0	Yes	No

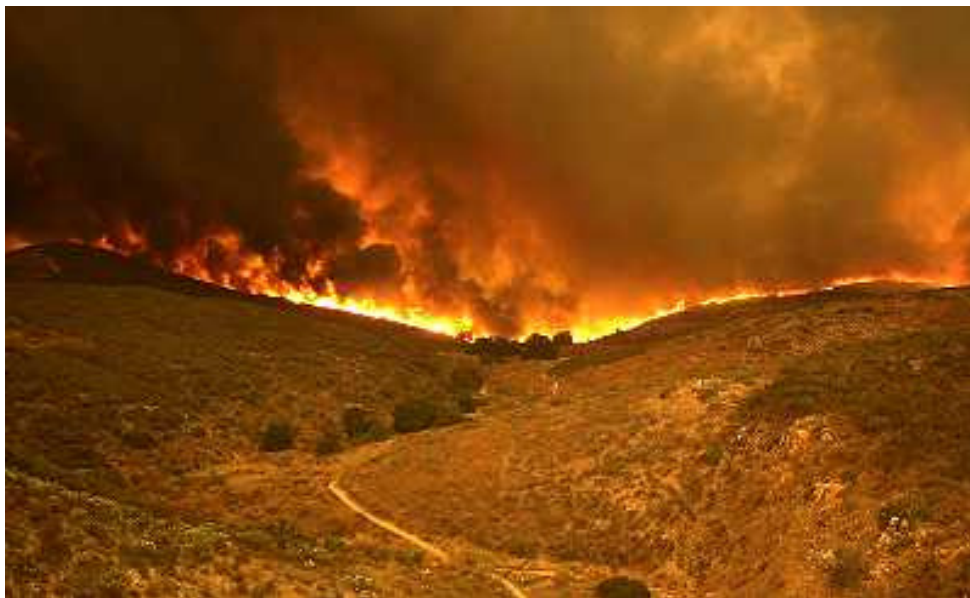
Figure 4-2: View of a Backfire to the Station Fire Behind Homes in La Crescenta.

The Station Fire burned 160,557 acres, 209 structures and caused 2 deaths. It is considered the 10th largest California fire by acreage burned (http://cdfdata.fire.ca.gov/incidents/incidents_statevents).
(Photograph by Jae C. Hong/AP Photo, taken on September 1, 2009).

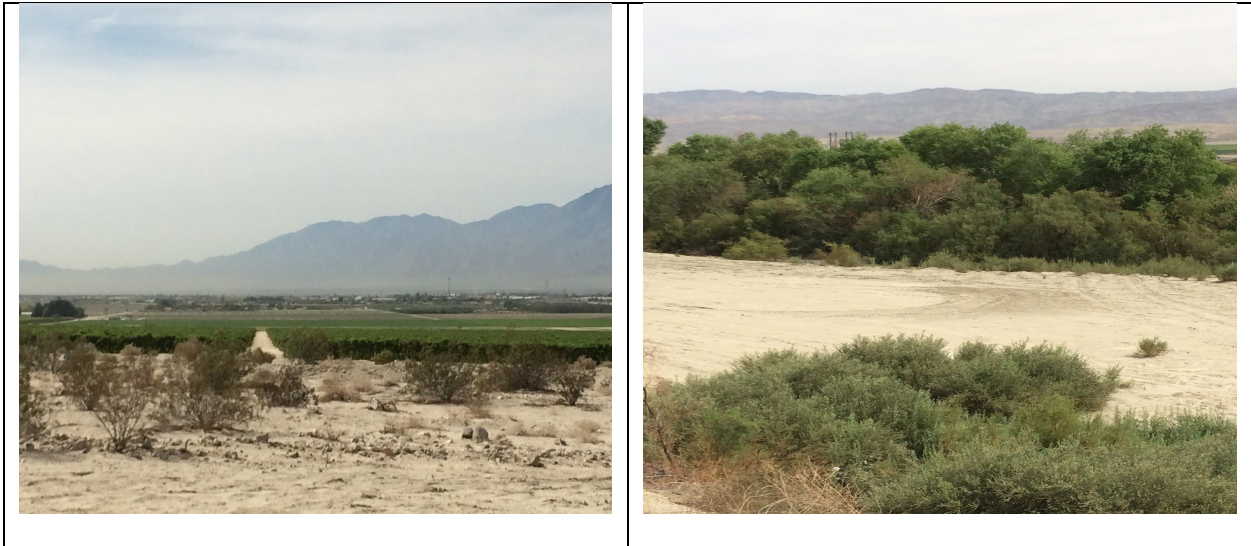
Photo at left shows typical desert vegetation in the foreground, cultivated vegetation in the background.

Photo at right shows dense stands of vegetation near the Whitewater River channel.

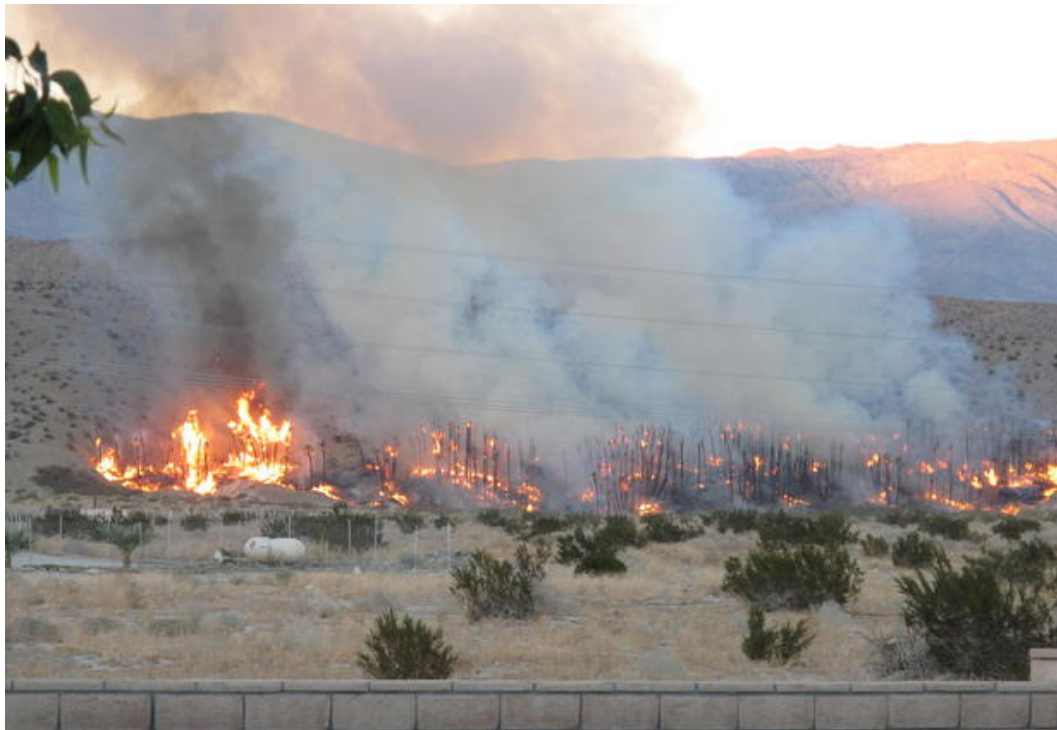
**Figure 4-4: Photo of a Wildfire in Thousand Palms,
With Barren Areas Limiting the Fire Spread**

In southern California, the predominant vegetation types generally germinate after the first rains of spring, and dry up in the fall, when the weather is dry and hot. This dried-up vegetation provides fuel for wildfires (Photo 4-4). In the desert bioregion, the primary factor controlling fire occurrence and spread is fuel condition, especially fuel type and continuity. Since fuel continuity is generally low in the region, fires typically do not spread beyond their ignition points. In the currently developed portions of the City, vegetation fires are not considered a hazard given the low topographic relief and low fuel loads. In the areas developed as agricultural fields, the carefully maintained and regularly watered vegetation combine to mitigate the potential for wildfires. Vegetation fires in these areas are possible, typically the result of intentionally set brush and grass fires, but these tend to be small in area (typically less than one acre in size), and less intense in heat than dense brush and forest fires.

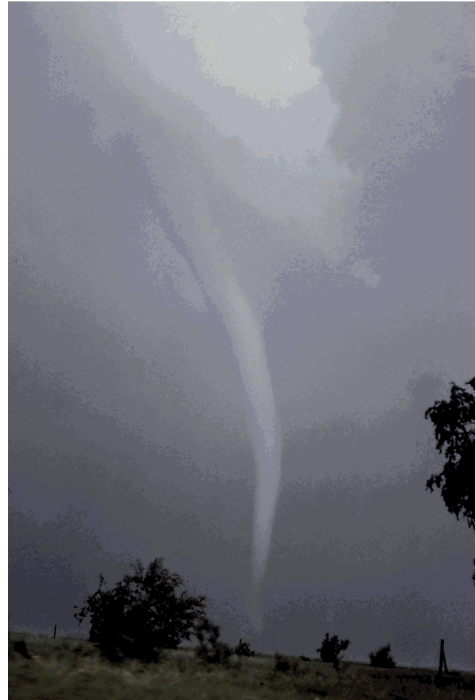
**Figure 6-2:
View of a Tornado**

To measure the intensity, area and strength of a tornado, in 1973 Dr. Ted Fujita (then with the University of Chicago) and Allen Pearson (at the time director of the National Severe Storm Forecast Center) introduced the Fujita-Pearson Tornado Intensity Scale (see Table 6-2). An improvement over the scale first published by Dr. Fujita in 1971, this scale compared the estimated wind velocity with the corresponding amount of damage to human-built structures and vegetation (a component first introduced by Fujita) and the width and length of the tornado path (the component added by Pearson). The scale classified tornadoes into six levels (from F0 to F5) with larger numbers indicating more damaging and larger tornadoes (the Fujita scale smoothly divided wind speed between the highest Beaufort level and Mach 1.0 (the speed of sound) into 12 levels – F0 through F12, but recognized that an F6 tornado would be inconceivable, and indeed no tornado above F5 has ever been measured. The Fujita-Pearson scale was used to classify all tornadoes reported after its introduction, in addition to retroactively classify all tornadoes reported since 1950 that were listed in the National Oceanic and Atmospheric Administration's (NOAA) national tornado database.
