Project Specific Water Quality Management Plan

For: **Vista Del Agua**

Tyler St. and 48th Ave, Coachella, CA

Christopher Lenz, PE
United Engineering Group
10602 Trademark Pkwy, Suite 509
Rancho Cucamonga, CA 91730
Telephone: (909) 466-9240

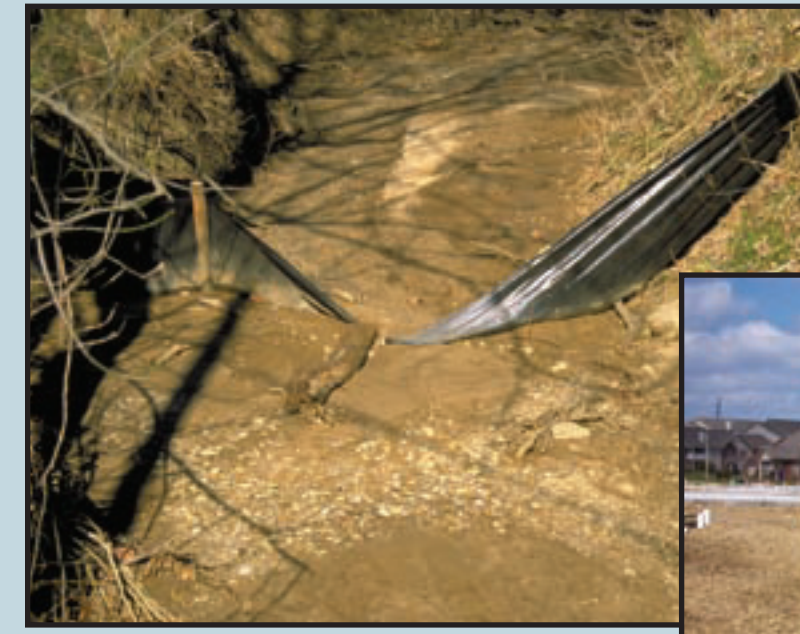
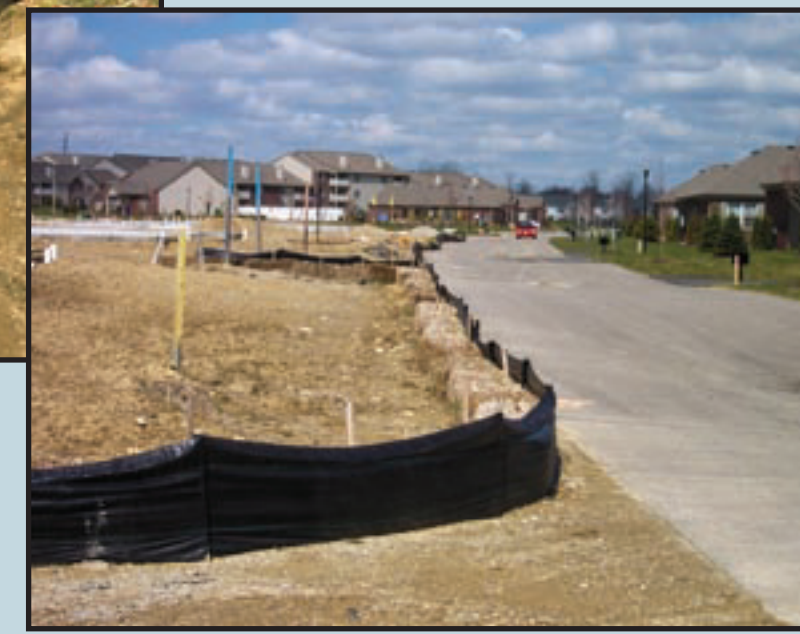
Silt Fencing

- Inspect and maintain silt fences after each rainstorm.
- Make sure the bottom of the silt fence is buried in the ground.
- Securely attach the material to the stakes.
- Don't place silt fences in the middle of a waterway or use them as a check dam.
- Make sure stormwater is not flowing around the silt fence.

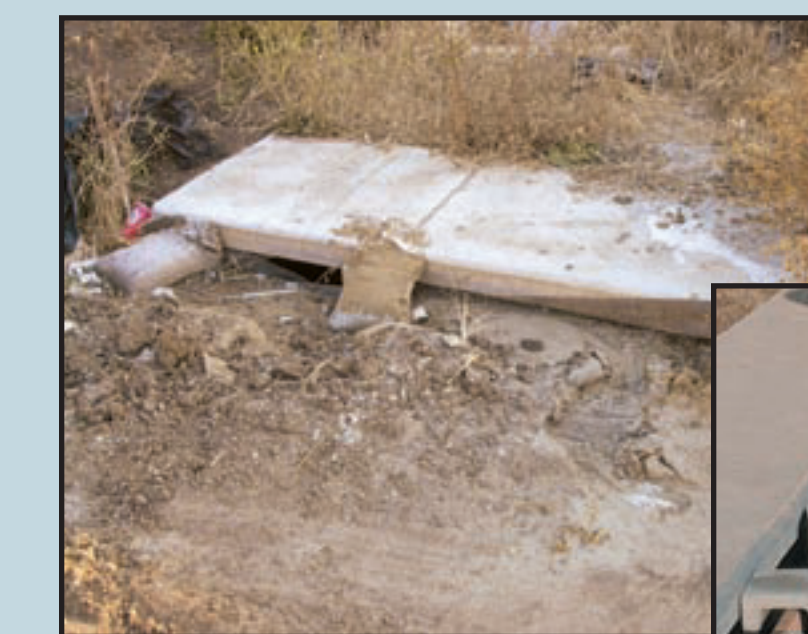
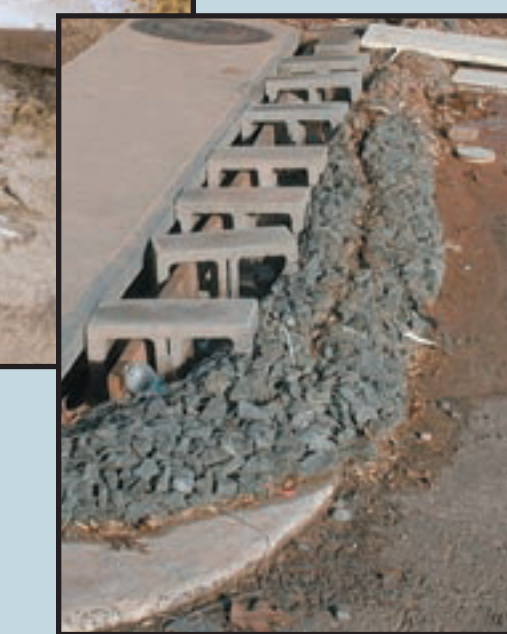
Storm Drain Inlet Protection

- Use rock or other appropriate material to cover the storm drain inlet to filter out trash and debris.
- Make sure the rock size is appropriate (usually 1 to 2 inches in diameter).
- If you use inlet filters, maintain them regularly.

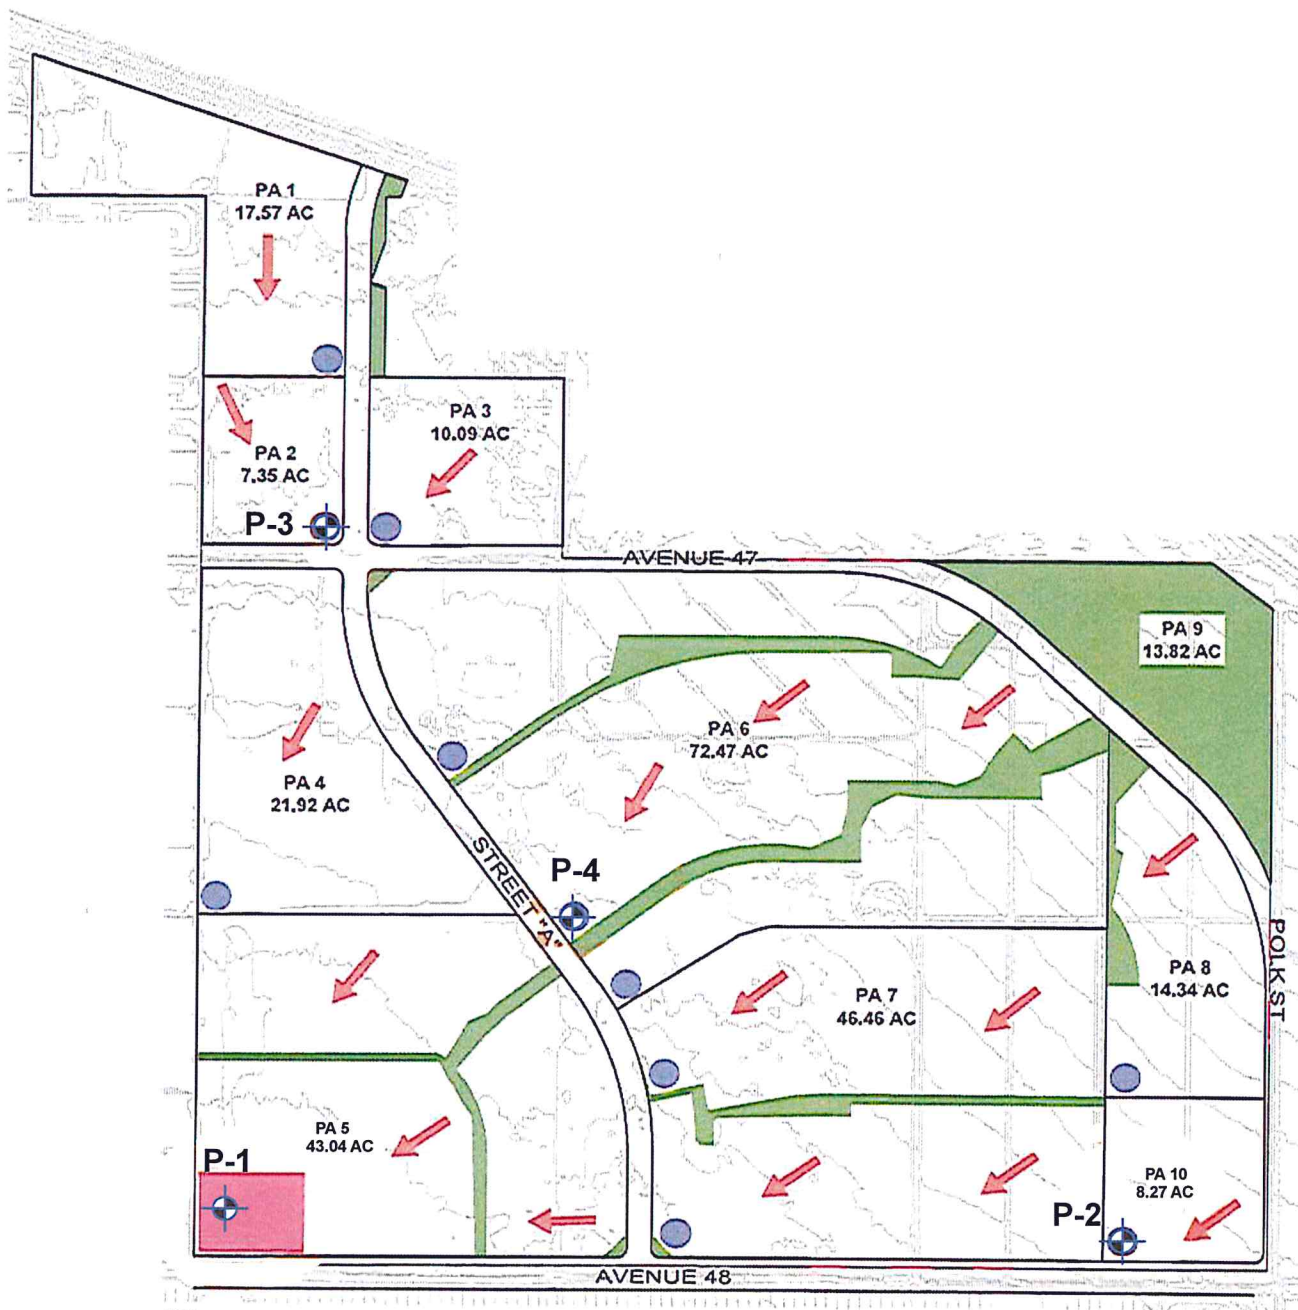
P-4 - Approximate Percolation Test Location
